BULL RUN DAM

6
National Dam Inspection Program. Bull Run Dam (NDI PA-463), Ohio River Basin, Bull Run, Westmoreland County, Pennsylvania. Phase I Inspection Program.

**PHASE I INSPECTION REPORT
NATIONAL DAM INSPECTION PROGRAM**

11/OCT/78

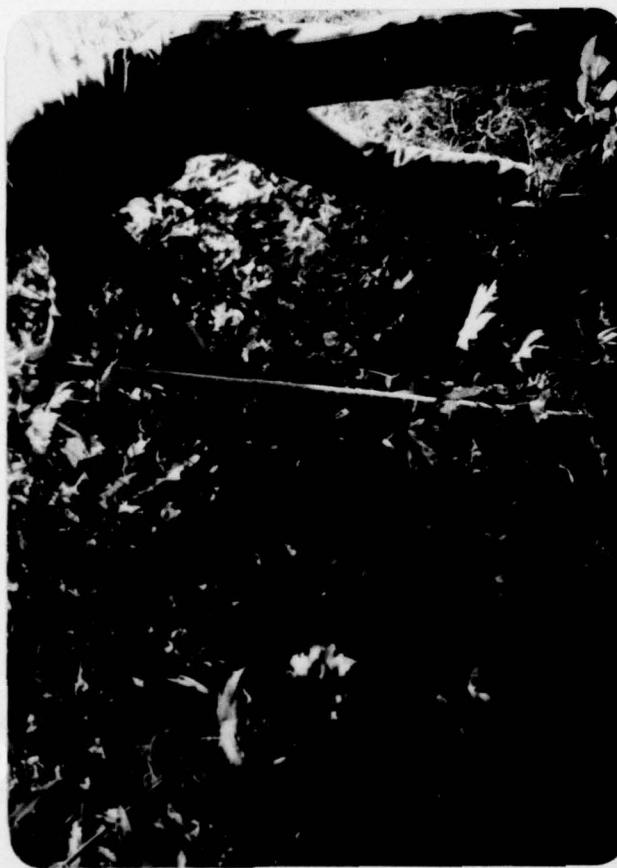
b. Embankment. Based on the visual inspection, the embankment is considered in good condition. No evidence of sloughing or erosion was observed. No evidence of past seepage during periods when the embankment impounded water could be detected. Since no water was impounded at the time of inspection, the performance of the dam could not be fully evaluated. The crest was well aligned and the embankment slopes consistent. Lack of regular maintenance was obvious in that both the upstream and downstream slopes were covered by dense vegetation (see Photographs 1 and 10). Several small maple trees (1.0 to 1.5 feet in diameter) were observed growing from stumps of older trees near the left wingwall of the spillway (see Photograph 9).

PHOTOGRAPH 9 Detail showing maple tree growing on the embankment near the forebay of the spillway. Although periodic cutting keeps the total height down, the stumps continue to increase in size as this picture shows.
